Inspection/Deficiency Report

Owner: Strata Plan VR1151
Project: Harbourside Terraces
Site address: 140 - 4th St. East, North Vancouver, BC
Time & Date: 10:00 am May 24th, 2022
Property Manager: Adil Moru (Property Manager) C & C Property Group Ltd.
Assigned Inspector: Paul Doyle **Contact#:** (604)704-7576
Contractor: Husky Painting Ltd
Project Manager: Son Hoang **Contact #:** (778) 388-0292
Paint Foreman: Hao Pham **Contact #:** (778) 895-8547
Site Contact: Simon Kirby **Contact#:** (604) 329-8253

I, Paul Doyle, am the assigned coatings inspector for The Harbourside Terrace painting project.

Today I was on site to inspect the corrected deficiencies from my last report and to inspect the first stages of the concrete wall repairs to the Parkade entrance walls.

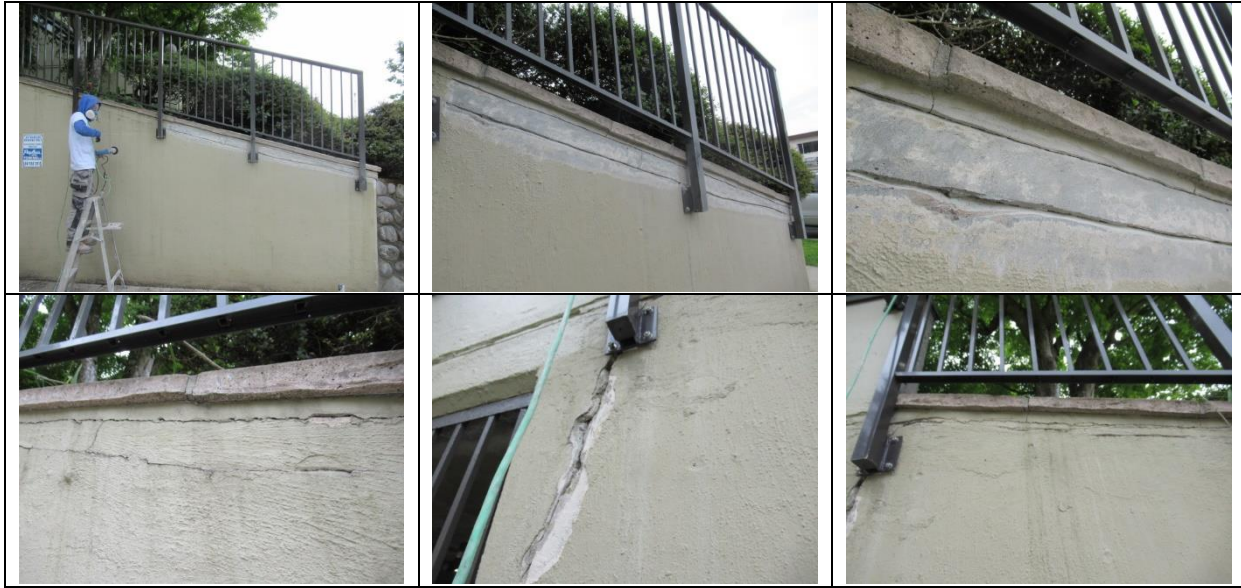
I met with Yet (Husky Painting Concrete Foreman) to discuss the repairs to the parkade concrete walls. At the time of my inspection the Husky Painting repair crew had ground out the cracks and removed the loose material.

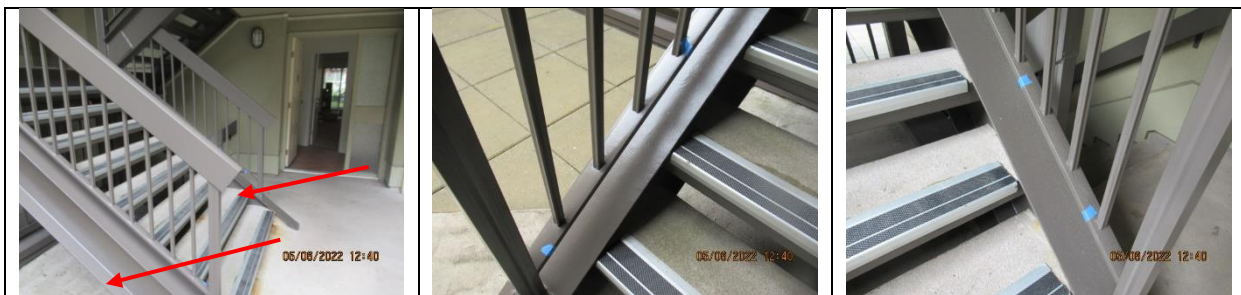
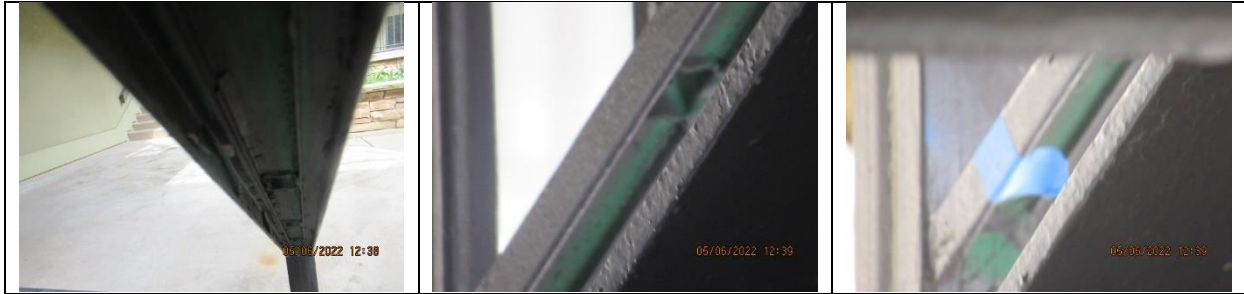
Lower Stairs - Unit 100:

- Scrape & sand any loose existing coating from the underside of the bottom rail on the handrail & apply 2 coats of the specified coating in the approved colour. **COMPLETED**

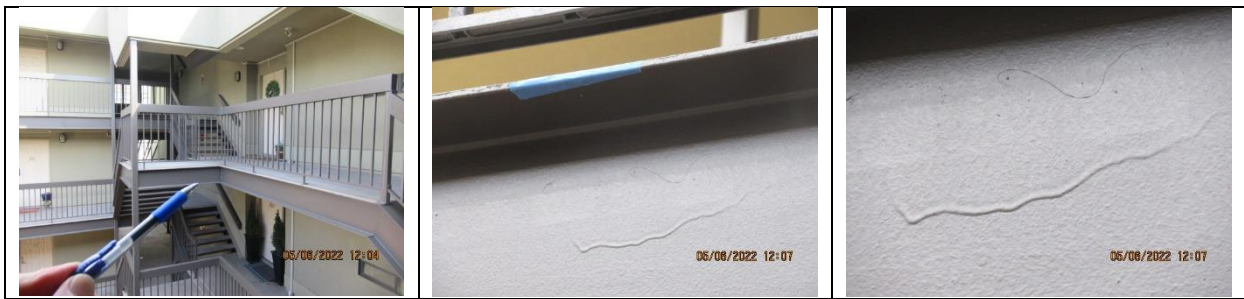
Upper Stairs 'I'-beam Northeast corner:

- There is a significant pre-existing paint run which remains to be scraped and sanded back and recoated with 2 coats of the specified coating. **COMPLETED**

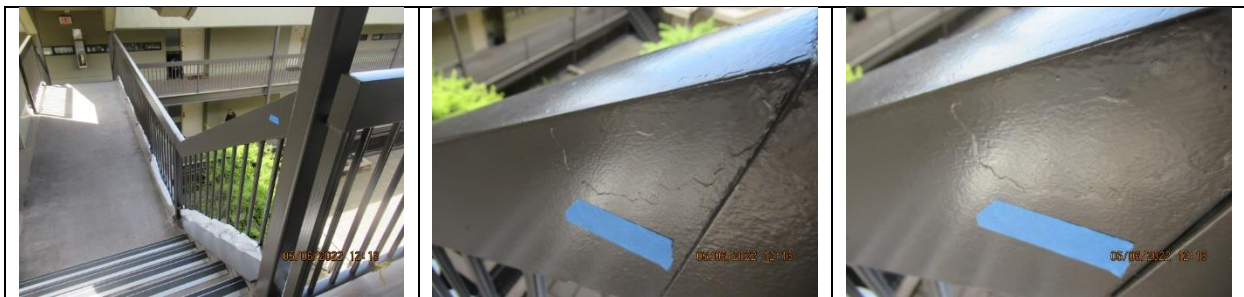
Center Elevator Stairs Railing – North side:

- Scrape & sand any loose existing coating from the underside of the bottom rail on the handrail & apply 2 coats of the specified coating in the approved colour. **COMPLETED**

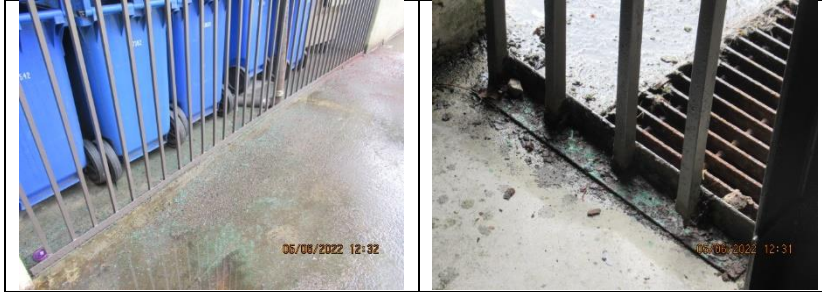
Please ensure the chipped concrete and loose paint chips are cleaned up from the driveway and garbage enclosure area when the painting crew returns to coat the Parkade entrance walls. Rain delayed this clean up previously and touch-ups remain to be done to the base plate of the garbage enclosure security bars.
